Procedia Environmental Sciences 12 (2012) 891 – 898

2011 International Conference on Environmental Science and Engineering
(ICESE 2011)

Model Test on Impact of Surrounding Rock Deterioration on Segmental Lining Structure for Underwater Shield Tunnel with Large Cross-Section

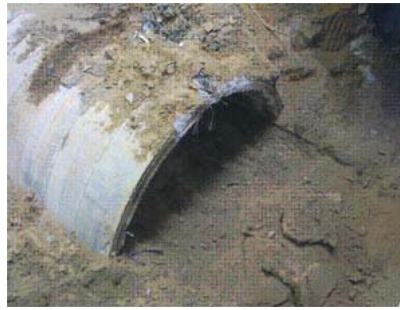
collapsed. Fig.1 shows the soil at left and right sides flowed into tunnel. And Fig.2 shows the failure state of segmental lining structure.

Fig.1 Scene of soil loss at both sides of shield tunnel

In actual projects, the surrounding rock instability and even segmental lining structure failure caused by TBM tunneling occurred frequently. For instance, an accident occurred at a work site of Shanghai Metro No.4 Line in 2003. As Ref. [1] and [2] described, the accident occurred after the main tunnel structure construction completed. When the connected aisle was constructing, about 270 m tunnel

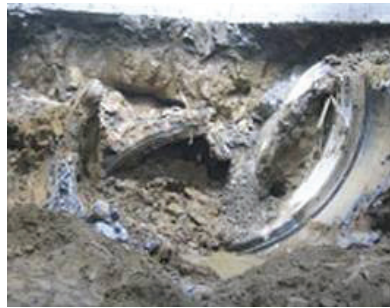
Fig.2 Failure state of segmental lining structure
